# Manhole Inspection Summary

Manhole # S25QQ1058MH

**Location** Address: **CLUB RD**

Cross Street: **UPLAND RD**

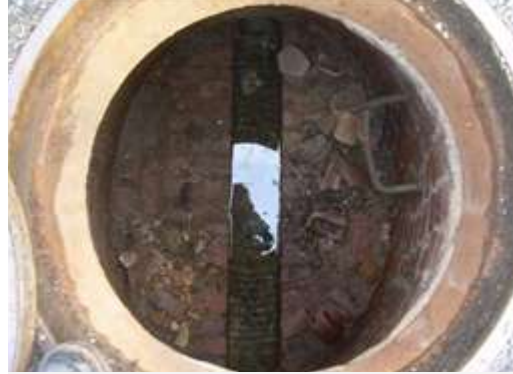
Top View

**Bench** ☒ Exists Material: **Brick** ☐ Parged ☒ **Debris** (not Condition related)

**Channel** Material: **Brick** ☐ Parged ☒ **Debris** (not Condition related)

**Surcharge** ☒ **Evidence Of Surcharge** Depth: **1** (ft.) ☐ Active Surcharge Present

Evidence of surcharge - Bench debris.  
Channel debris.

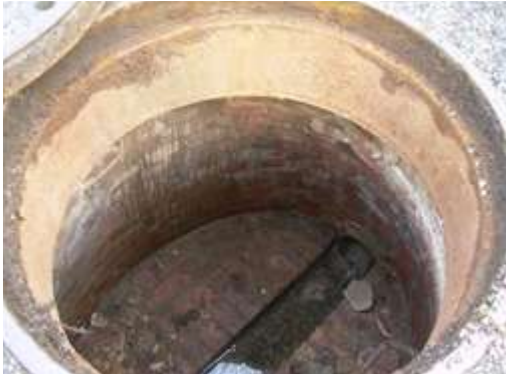
Defect

**Frame** Offset: **0** (in.) Condition: ☐ Sound ☐ Cracked ☒ **Leaks**

Condition: ☐ Sound ☐ Cracked ☐ Root Intrusion ☐ Loose Brick ☒ **Deteriorated**

Infiltration: ☐ None ☒ **Joint** ☐ Cracks ☐ Mortar ☐ Roots ☒ **Wall**

Infiltration: ☐ None ☐ Joint ☐ Cracks ☒ **Mortar** ☐ Roots ☒ **Wall**

Frame leaks. Corbel deterioration and  
infiltration. Barrel infiltration.

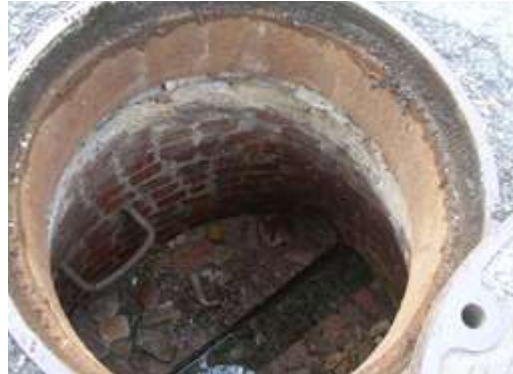
Defect

Frame leaks. Corbel deterioration and  
infiltration. Barrel infiltration - other side.

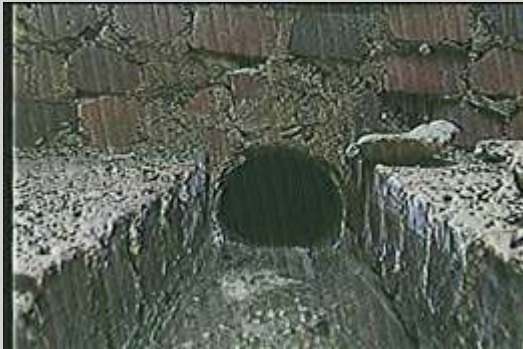
### 6 in. Circular Gravity Sewer Pipe Out @ 12 O'Clock

Condition: ☐ Sound ☐ Cracked ☐ Root Intrusion ☒ **Deteriorated** ☐ Leaks ☐ Debris

Channel deterioration.

Deposits: ☐ None ☒ **Mud** ☐ Sludge ☒ **Debris** ☐ Grease

Infiltration: **None** Pipe Seal Cond: **Cracked**

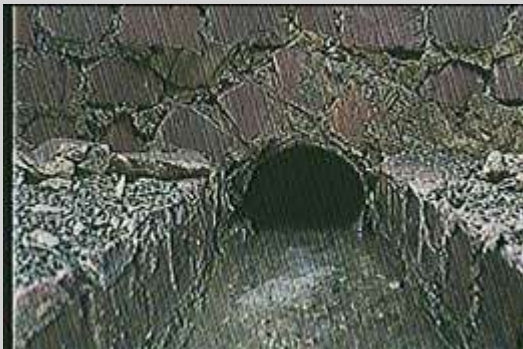
### 6 in. Circular Gravity Sewer Pipe In @ 6 O'Clock

Barrel deterioration and infiltration.

Deposits: ☐ None ☒ **Mud** ☐ Sludge ☒ **Debris** ☐ Grease

Infiltration: **Evidence** Pipe Seal Cond: **Broken**
